# **CASE HISTORIES OF WETLAND RESTORATION**

U.S. Department  
of Transportation

Federal Highway  
Administration

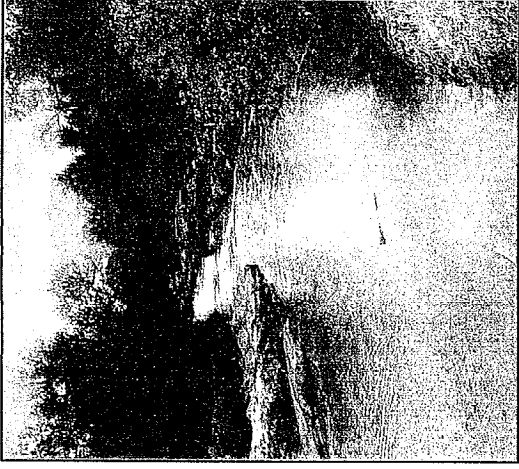
Channel section after removal of log jam

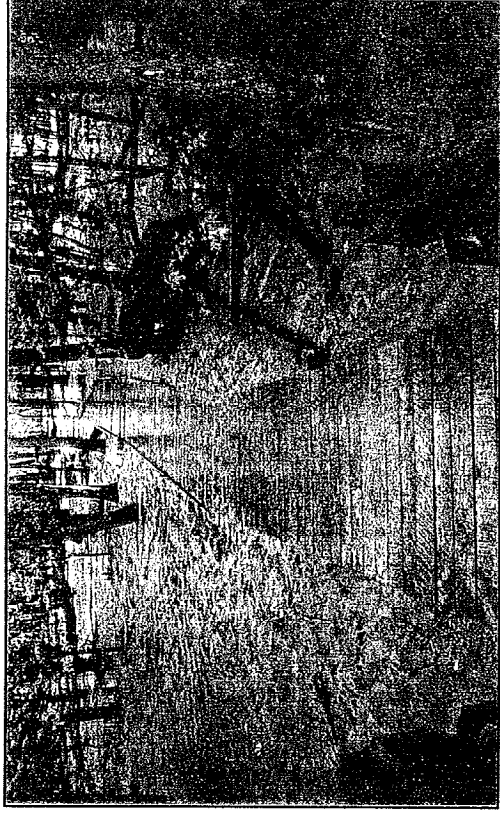
Sediment released by removal of log jam smothering herbaceous layer in forested wetland

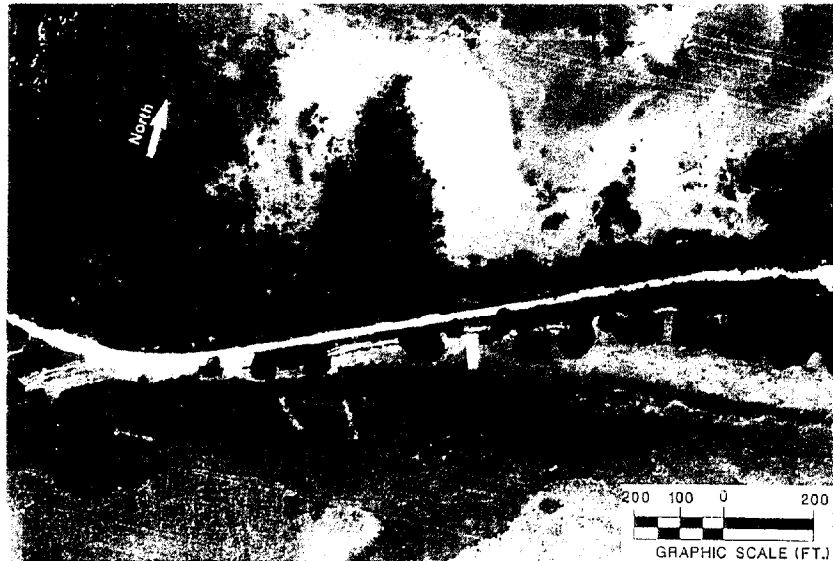
Vertical aerial photograph taken February 25, 1981, of the south side of the Boca Chica Lagoon at the location culvert C4. Reference points R1, R2, and R3 are also shown below. Arrow indicates future location of culvert (see below).

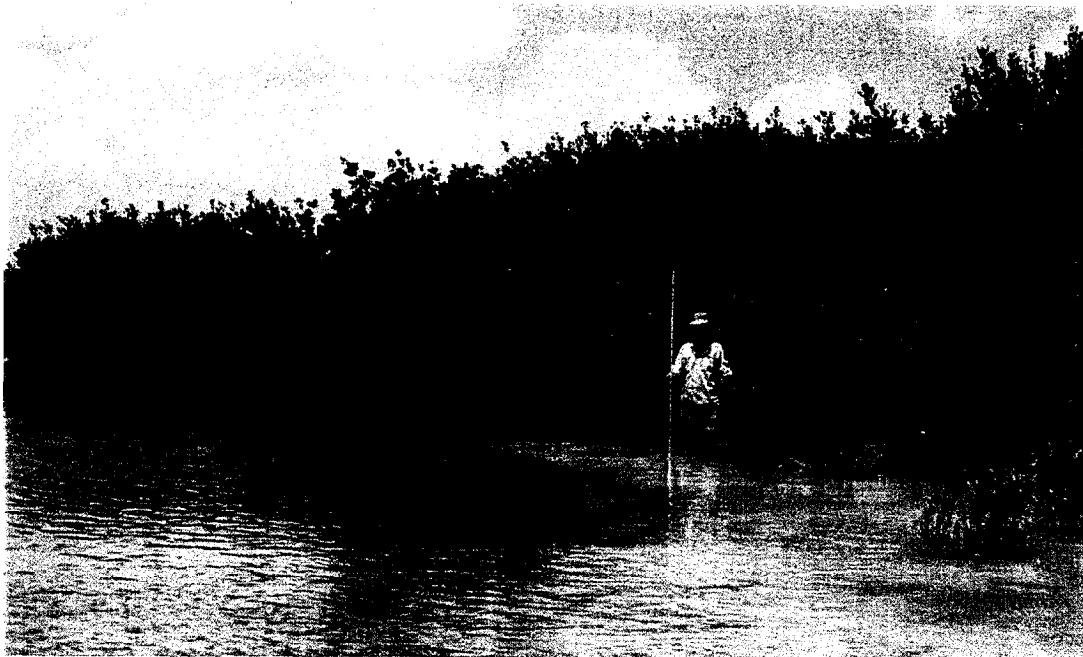
Typical volunteer and planted red mangroves at culvert C-4, Boca Chica Lagoon, 1993. Staff is 2 m tall.

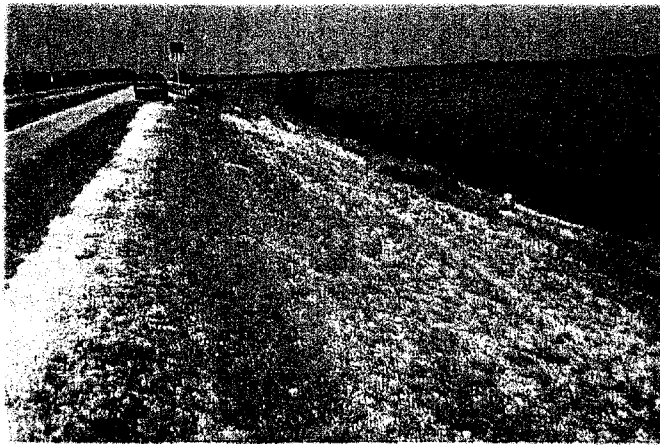
Lower Sugarloaf Channel, erosion limiting  
revegetation, Miami Gulf side, view west,  
5/93.

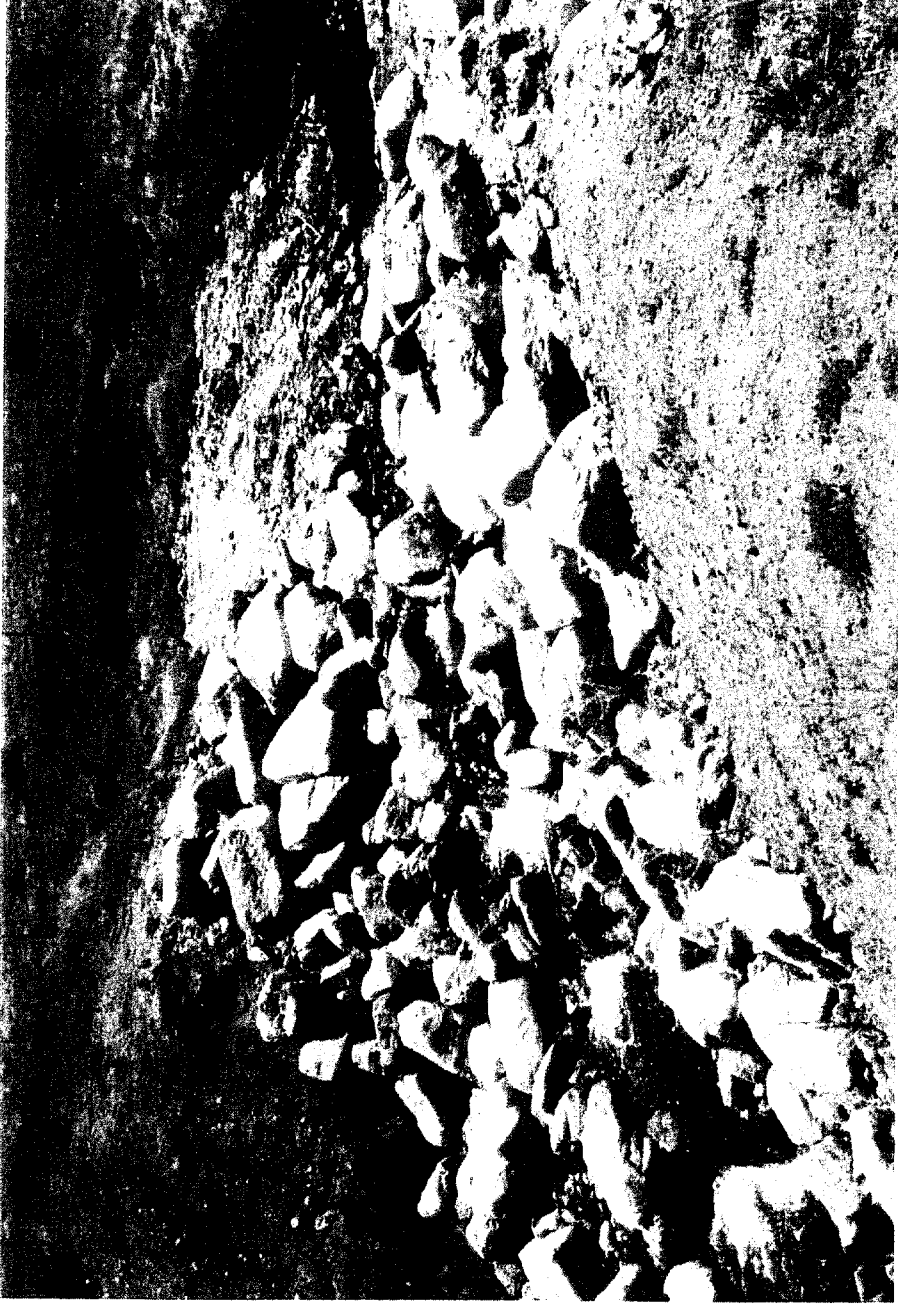
EXHIBIT 6-6: CONSTRUCTED ROCK WEIR IN ABANDONED RAILROAD EMBANKMENT  
(PHOTOGRAPH BY KRISTINE MEIRING)

Construction of the new stream corridor and onsite mitigation along the North Fork of the South Platte River proceeded concurrently with the construction of the road. The contractor was overseen by inspectors of the CDOT. Wetland soils were removed from the areas to be covered by the widened roadway and from the portion of the stream which was to be relocated, stockpiled for a short duration, and then respread in the flood plain of the reconstructed channel to help establish wetlands. Some materials such as boulders, cobbles, and topsoil that were not used for the onsite mitigation were stockpiled for use in the off-site area. Existing vegetation, including trees, was left along the new channel edge adjacent to the roadway to provide a buffer between the road and the new channel to minimize noise and visual impacts. The buffer vegetation, including plants from the seed bank, also would act as a filter for highway runoff. A drainage ditch was dug parallel to the highway to provide detention and sediment removal prior to discharge of runoff to the stream.

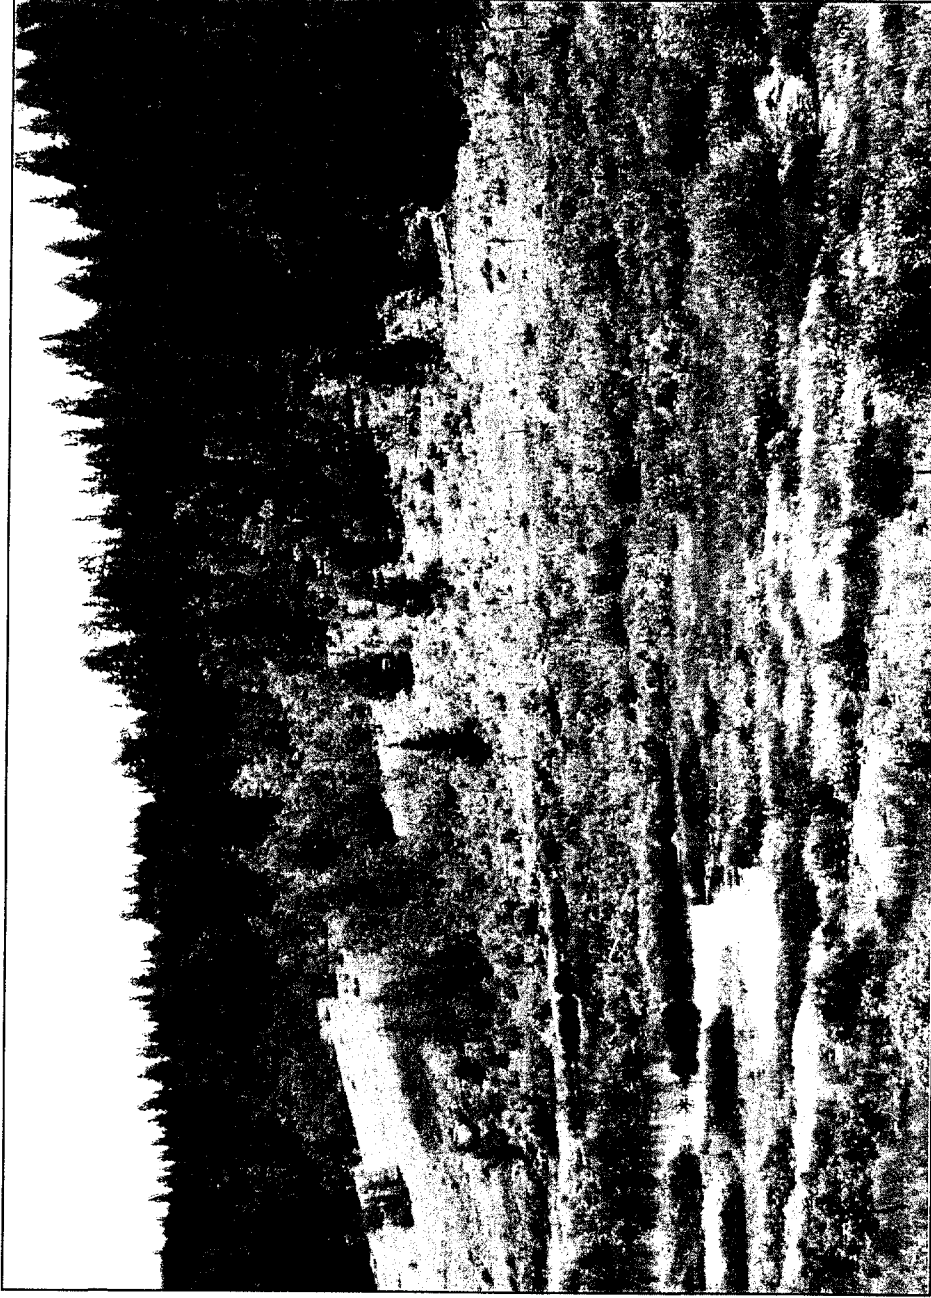
EXHIBIT 6-10: RESTORED SEDGE MEADOW WITH SHRUB CARR FRINGE (PHOTOGRAPH BY KRISTINE MEIRING)
